Mt. Scott Creek Dam Removal

Happy Valley, Oregon

Highlight: Mt. Scott Creek

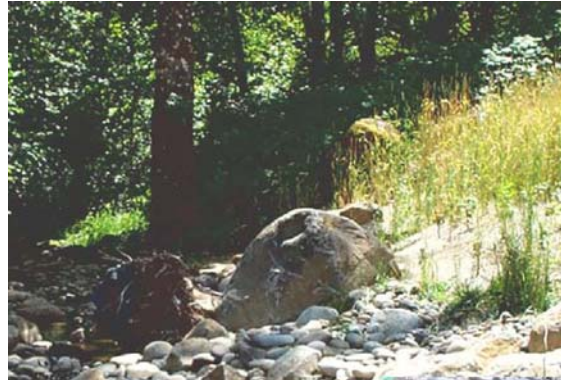
Placement of boulders, cobble, gravel, and sand create the stream channel.
